Technical Preservation Services
Preservation Assistance Division
National Park Service
U.S. Department of the Interior
Washington, D.C.

Interpreting the Secretary of the Interior's Standards for Rehabilitation

Volume III

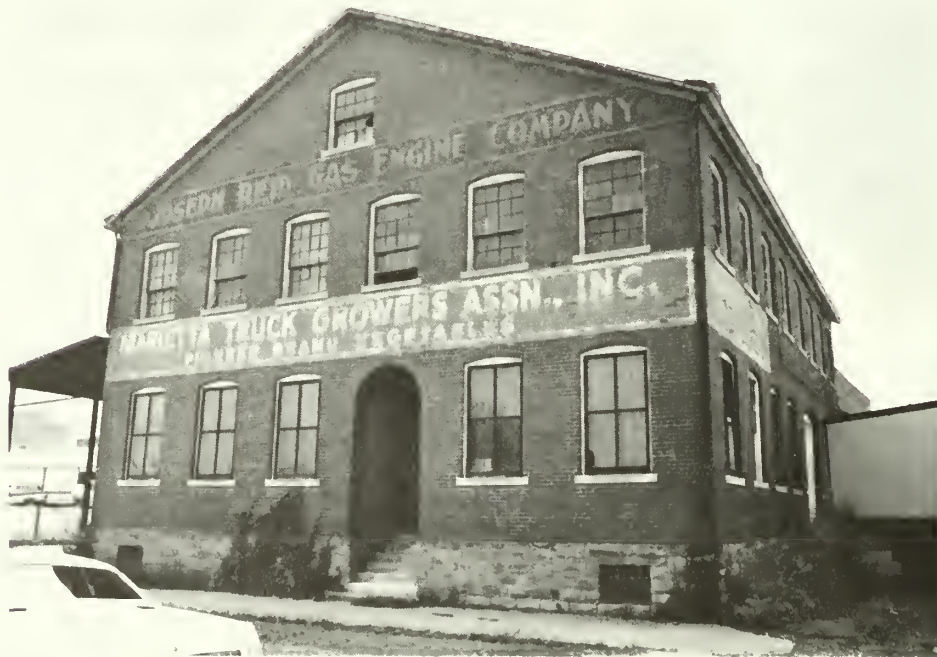
1. Front elevation of the 1880 manufacturing facility as it appeared prior to the rehabilitation.

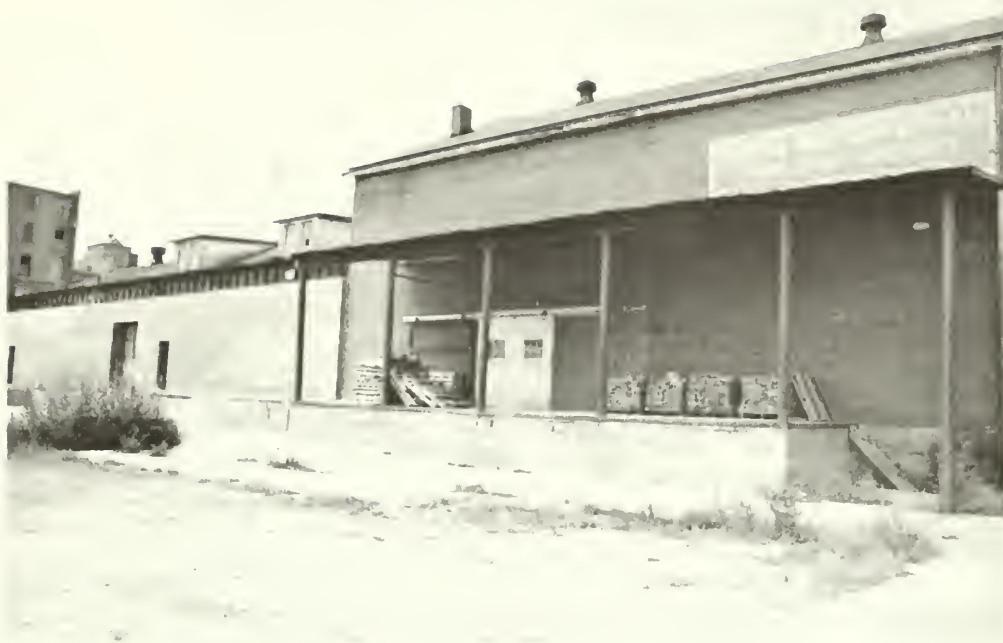
2. South side elevation of the building with roof-covered loading dock prior to rehabilitation.

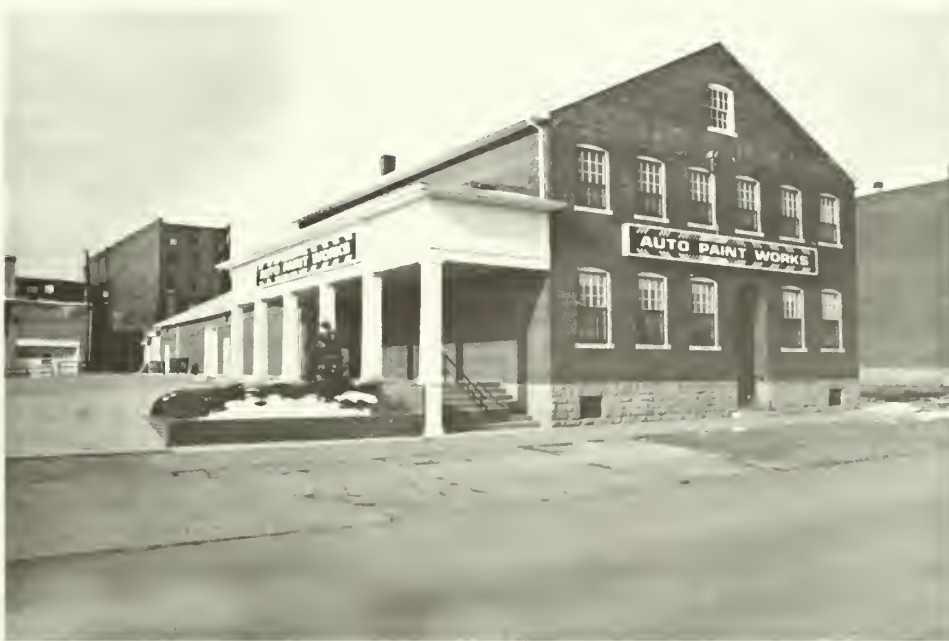
3. Photograph of building after rehabilitation with construction of portico.

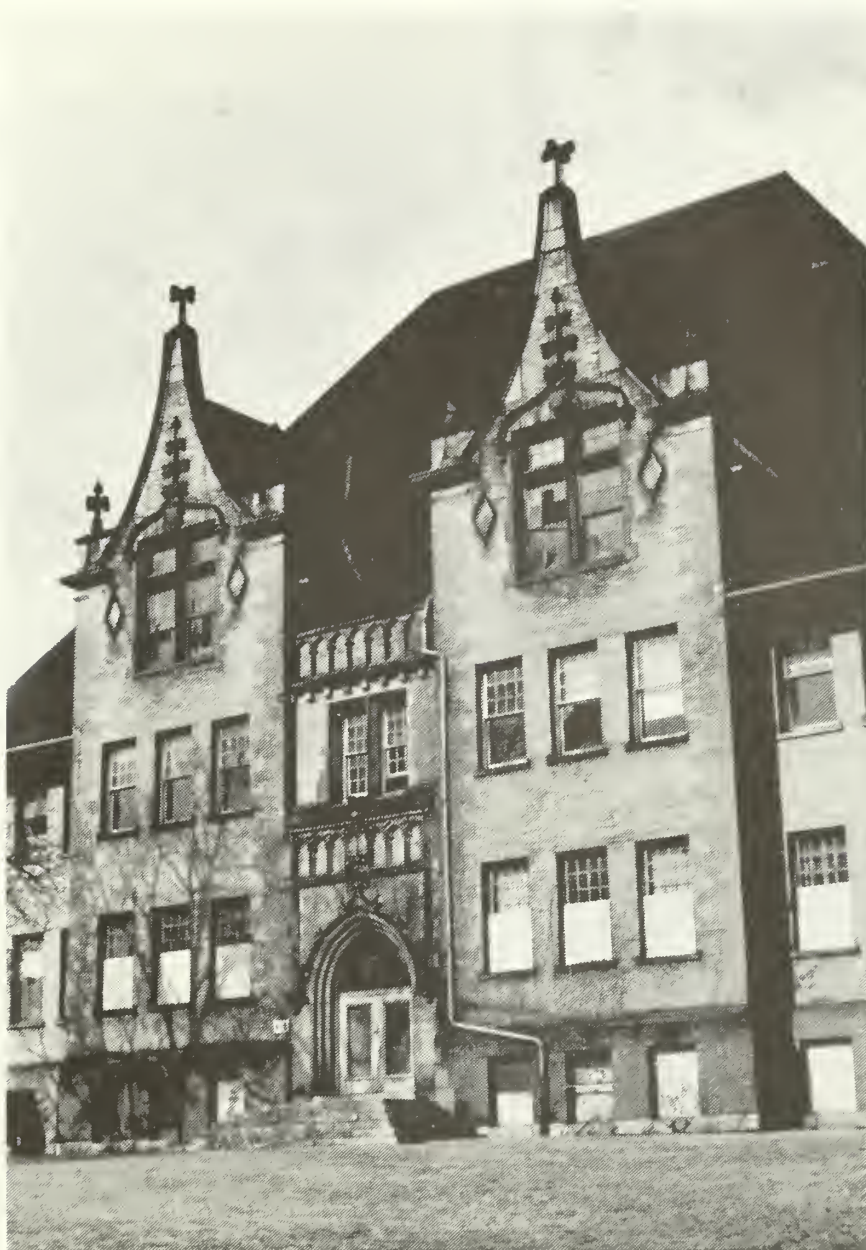
1. The former school building is characterized by its distinctive form--massive yet only three stories in height--its twin towers, unusual arch-shaped entrance and series of large-scale, twelve-over-one windows that were designed to provide maximum daylight in the classrooms.

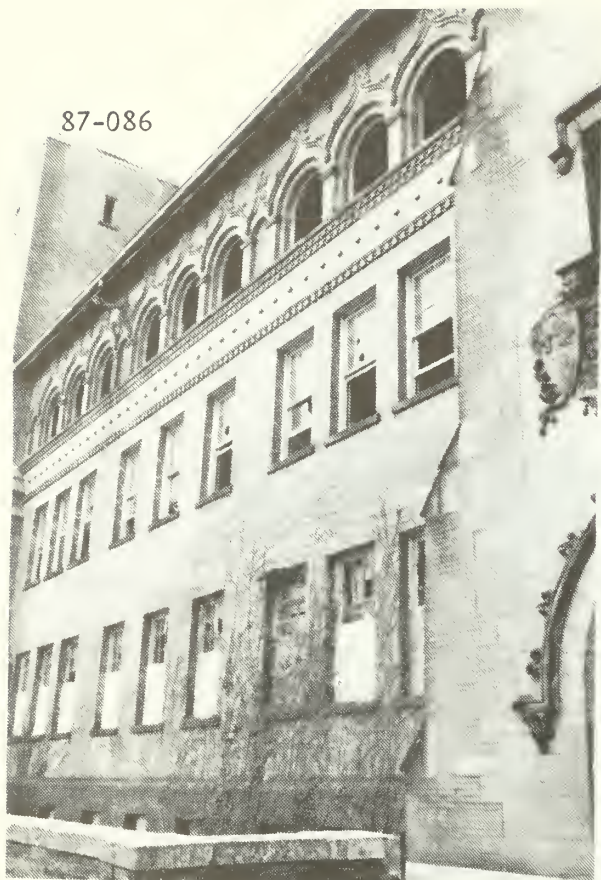
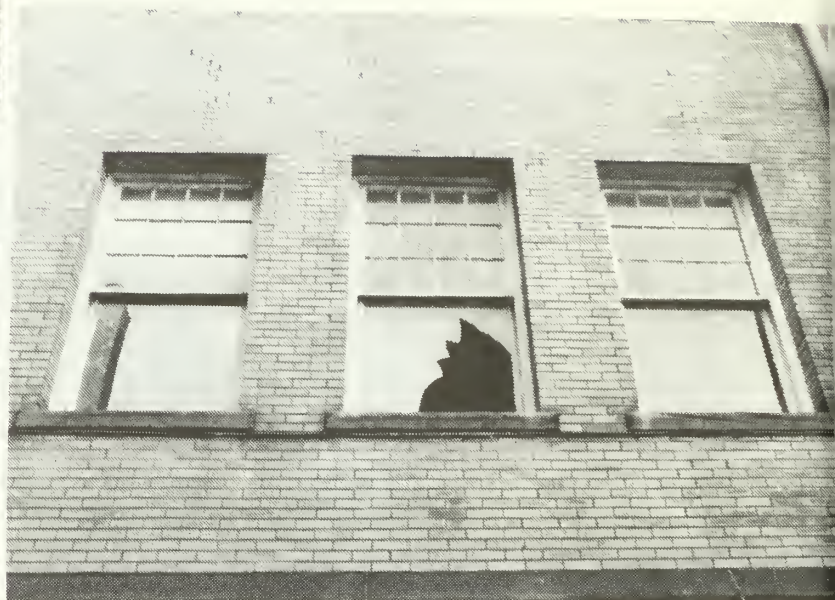
2. and 3. The windows and window openings as one would see them close to the building's walkway entrance establish the importance of their design and detail.

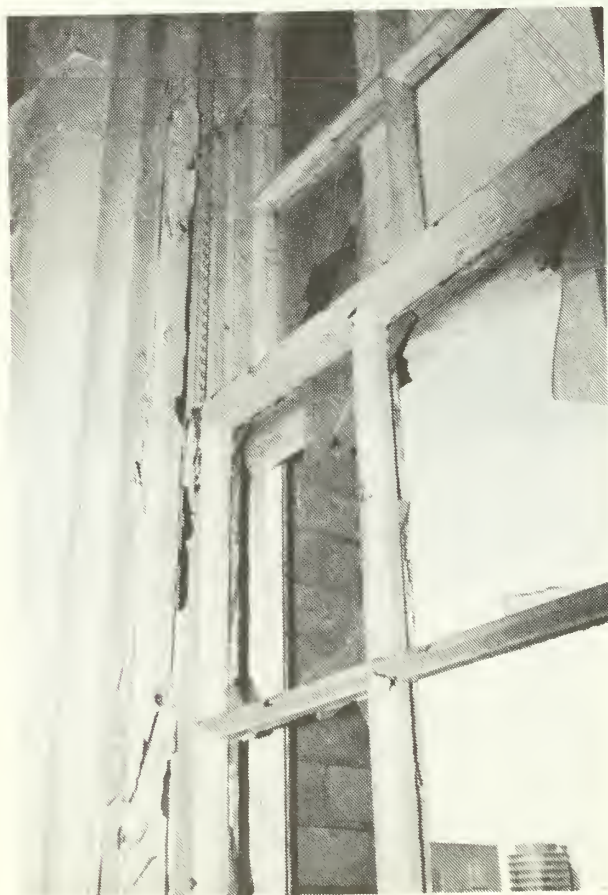
4. From inside as well, the detail, design features, shadow lines and finishes are all part of the character of the window. If a historic window is so deteriorated that it needs to be replaced, a matching replacement window is the most appropriate choice to meet the Secretary's Standards within a rehabilitation project.

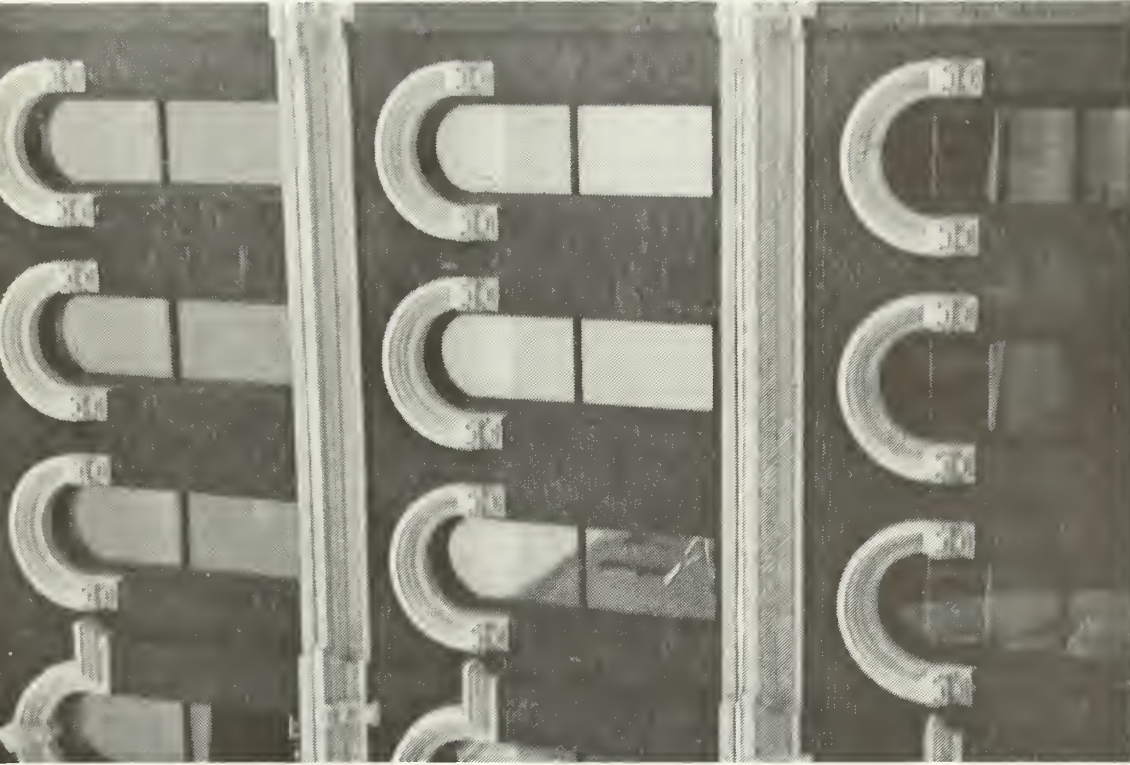
2. After rehabilitation and installation of the new windows, the "eyebrows" seem to float--disconnected--above the dark brown fixed sash.

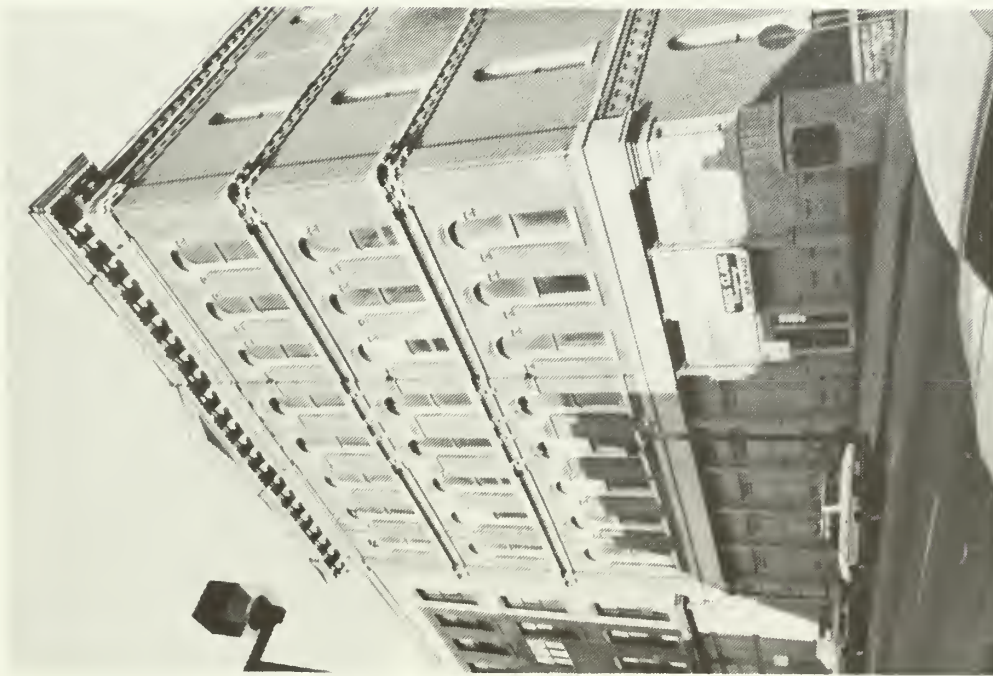
1. Before rehabilitation, the front elevation of the 1875 commercial building is shown with its distinctive "eyebrow" ornamentation framing the one-over-one, circle-top, double hung windows. Because the sash and eyebrows are all painted a light color, they are perceived historically as a unified design component.

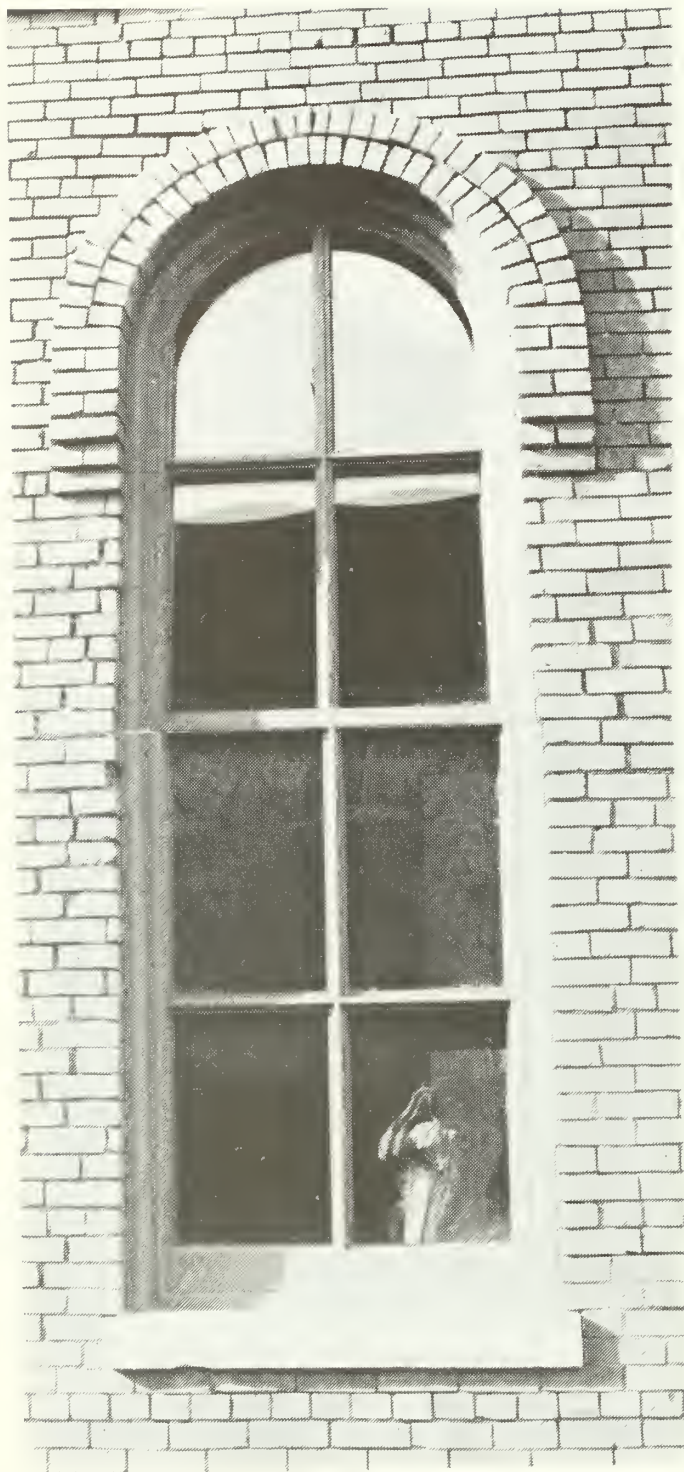
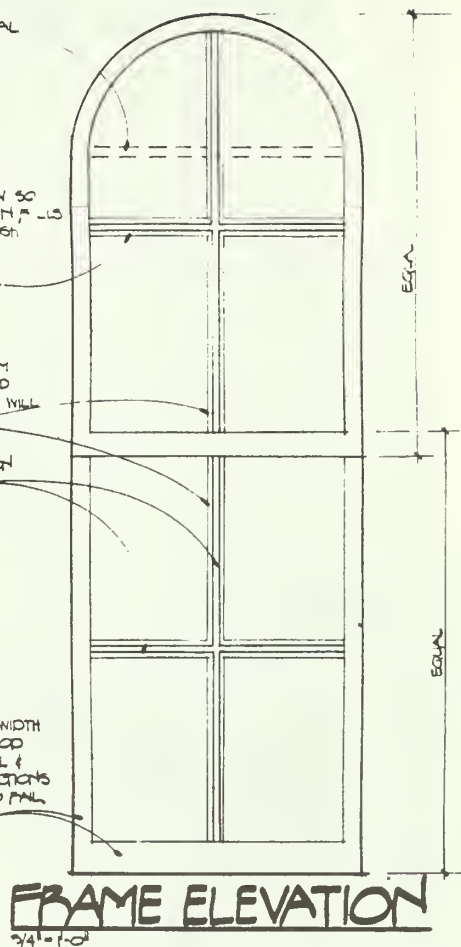
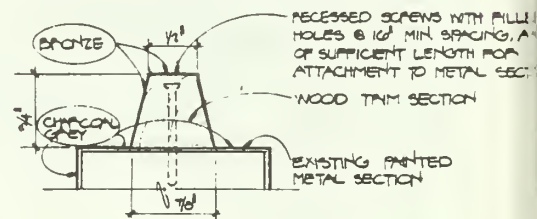
7. In alternative B, proposed changes included installation of a wood brick molding. In an attempt to make the muntin appear thinner and visually recessed, the wide aluminum muntins would be painted a charcoal gray; trapezoidal shaped wood strips would also be applied to the existing flat muntin and painted to match the existing window color. Even making these modifications, the replacement window did not match the detailing of the historic window--the depth of the frame and muntin was still far too shallow, and the muntin profile and width was still inappropriate. This proposal was also rejected.

REMOVE TOP HORIZONTAL
MUNTIN & GLASS

RESTRUCTURE WINDOW SO
TOP HORIZONTAL MUNTIN IS
MIDWAY BETWEEN TOP SASH
SECTION

APPLY WOOD TRIM SECTION
TO PAINTED MUNTINS

APPLY 3/4" THICK x FULL WIDTH
(OF EXISTING SECTION) WOOD
SECTIONS TO HORIZONTAL &
VERTICAL PERIMETER SECTIONS
& TO HORIZONTAL MEETING PAIR
COLOR TO BE BRONZE

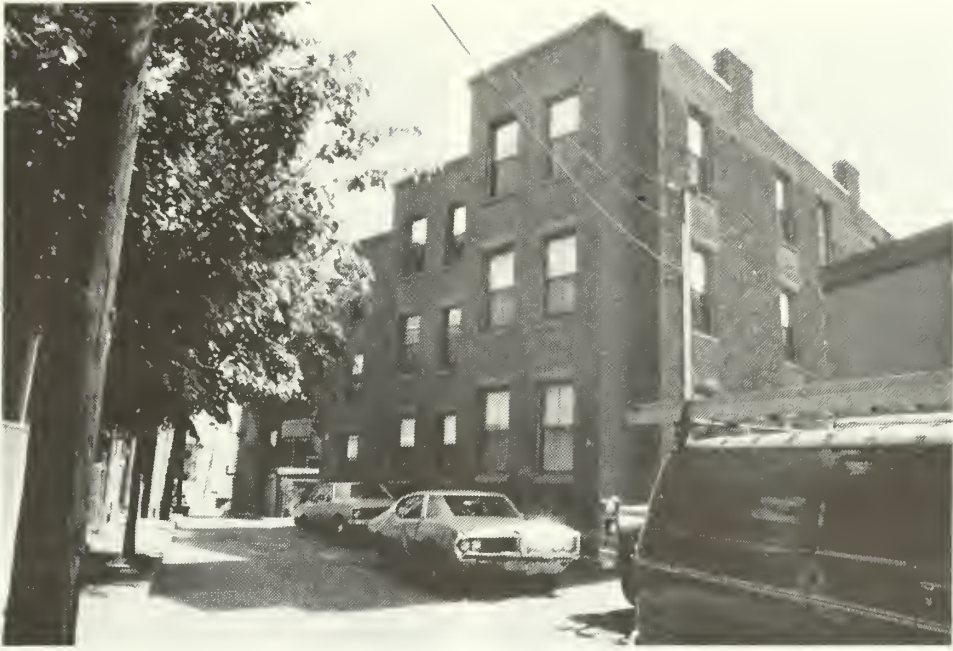
1. Pre-rehabilitation photograph of workers' rowhouses (front elevation).

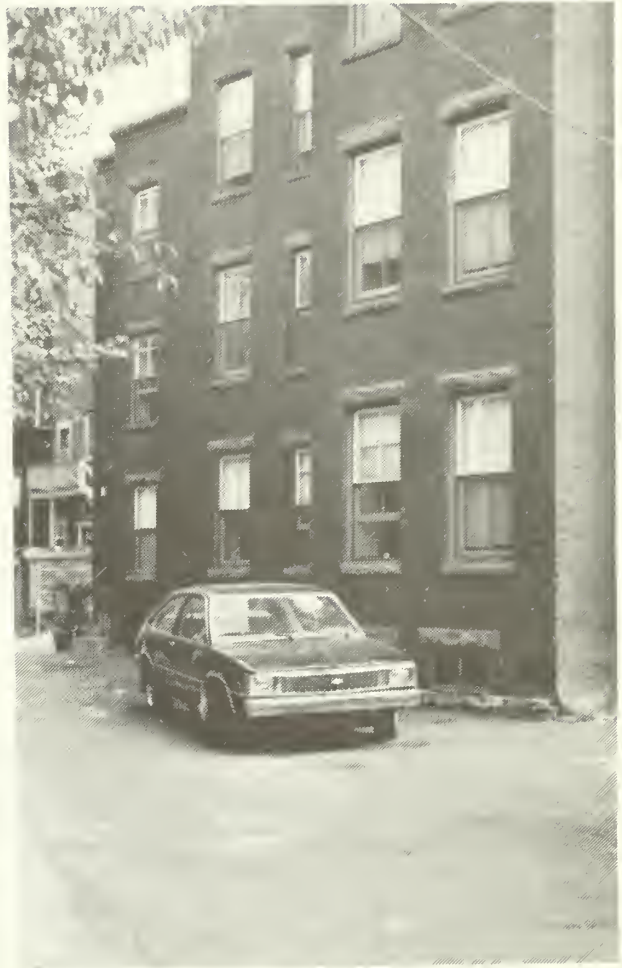
6. Post-rehabilitation photograph of historic rowhouses with matching wood windows.

To bring this rehabilitation into conformance with the Standards, the owner decided to replace the new aluminum windows, which were clearly visible from the street, with new wood sash duplicating the originals in size, profile, muntin configuration, and composition (see illus. 5 and 6). With the new wooden sash in place, the project was subsequently certified.

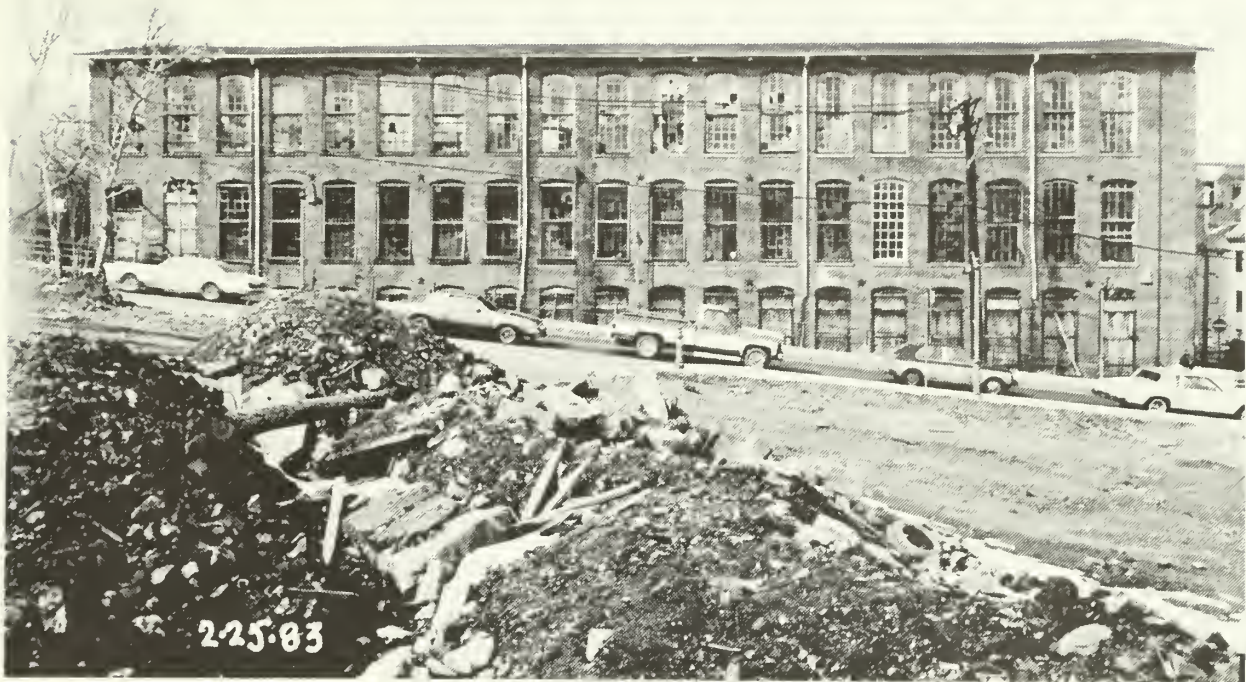
1.

1-2. Pre-rehabilitation view of the building showing deteriorated 16-over-16 windows. Note previous owner's effort to duplicate arch-headed sash with sample unit on 2nd floor. In the view below, note how the upper and lower sash are set on different planes, a characteristic feature of double-hung windows.

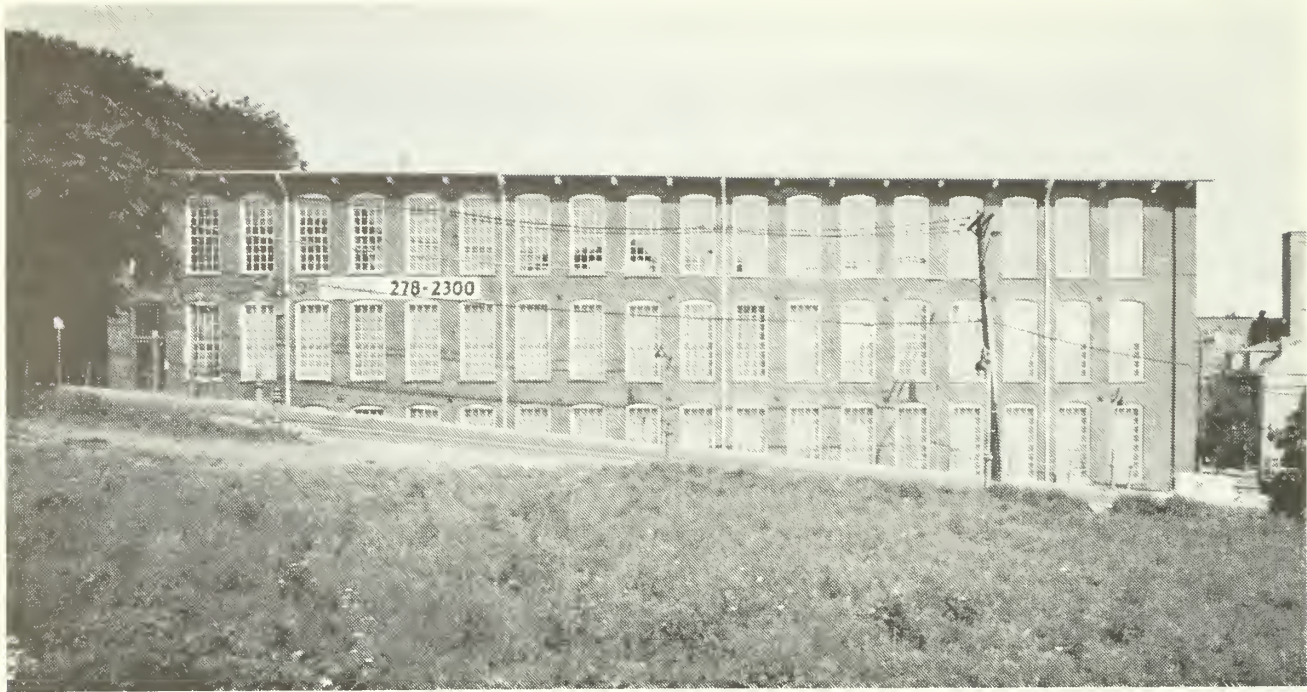
3.

The replacement windows, however, did not adequately duplicate the visual qualities of the historic windows, specifically in appearance, shadow lines, muntin detail and planar qualities. In addition to the change from an arch-headed to a square-headed sash, a number of other distinct changes have occurred to the historic appearance of these windows. The double-hung, historic wood windows have been replaced by fixed metal units with much narrower sash dimensions, noticeably changing the planar relationship of the upper and lower sash. The resultant effect is that at certain angles the replacement windows have the appearance of the upper and lower sash being in the same plane, rather than duplicating the appearance of the historic, double-hung sash (see illus. 3-5).

3-5. Post-rehabilitation view of the building showing replacement windows. In 5, note how the reduction in depth of the meeting rail has produced a flat appearance to the window. The appearance of a historic double-hung window with sash on different planes and a heavy shadow line created by the meeting rail has been lost.

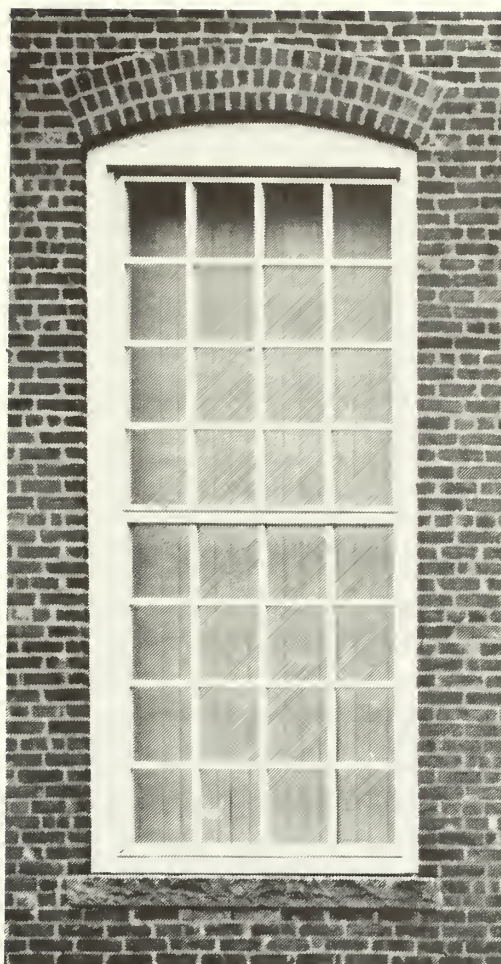
5.

The thickness of the meeting rail so evident in the historic sash has been reduced in depth creating a weaker shadow line (see illus. 5). The use of an applied aluminum muntin grid rather than true 16-over-16 wood muntin divisions has caused significant changes to the appearance of the windows (see illus. 6). The muntin grid clearly does not match the original, since the new muntins have a rectangular rather than trapezoidal profile, it has a ribbed surface, and it extends beyond the plane of the rails and stiles. The projecting grid, furthermore, creates additional shadow lines that did not exist on the historic windows. The historic muntins were flush to the surface of the sash, integral to the sash frame construction and trapezoidal in shape after puttying.

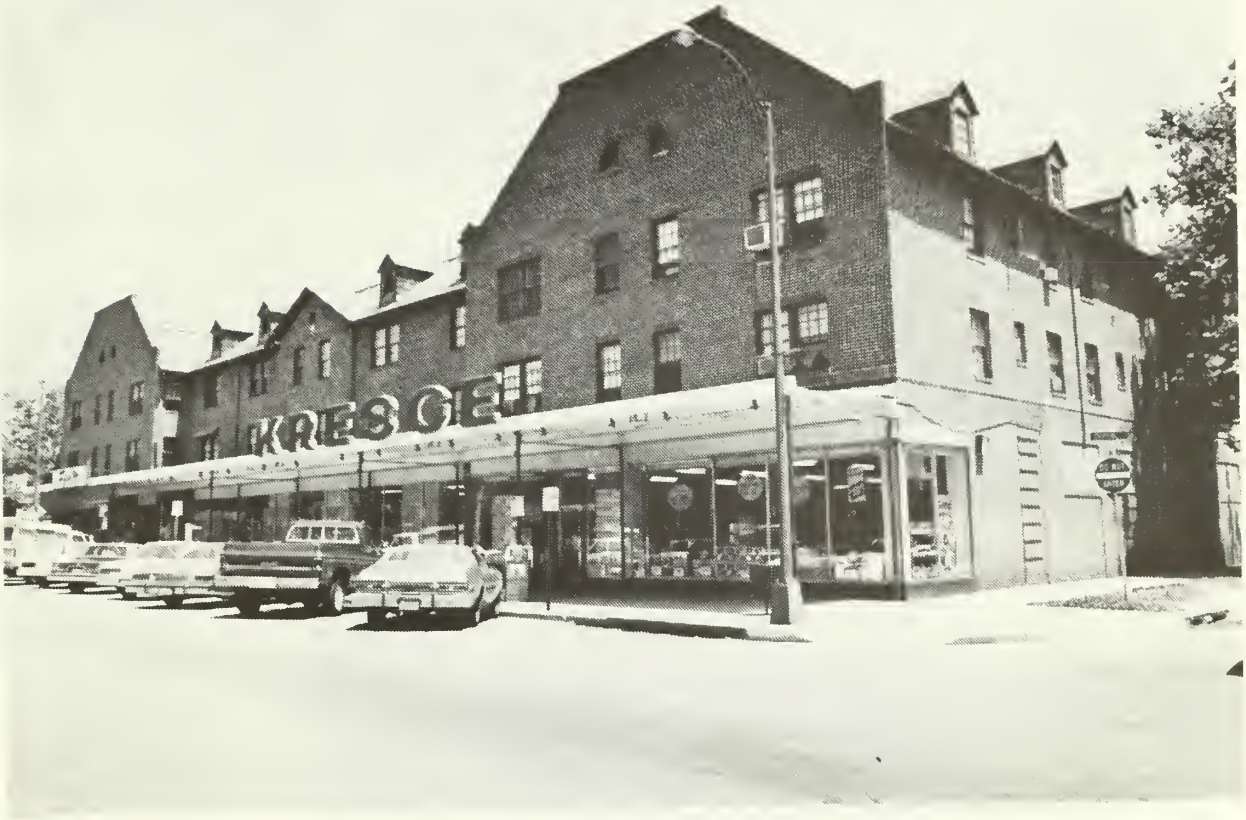
Building 1

1-3 Pre-rehabilitation views demonstrate the residential scale of the second and third floor windows. Note how the dark color of the window sash and frames makes the windows less prominent on the upper floors of buildings 2 and 3.

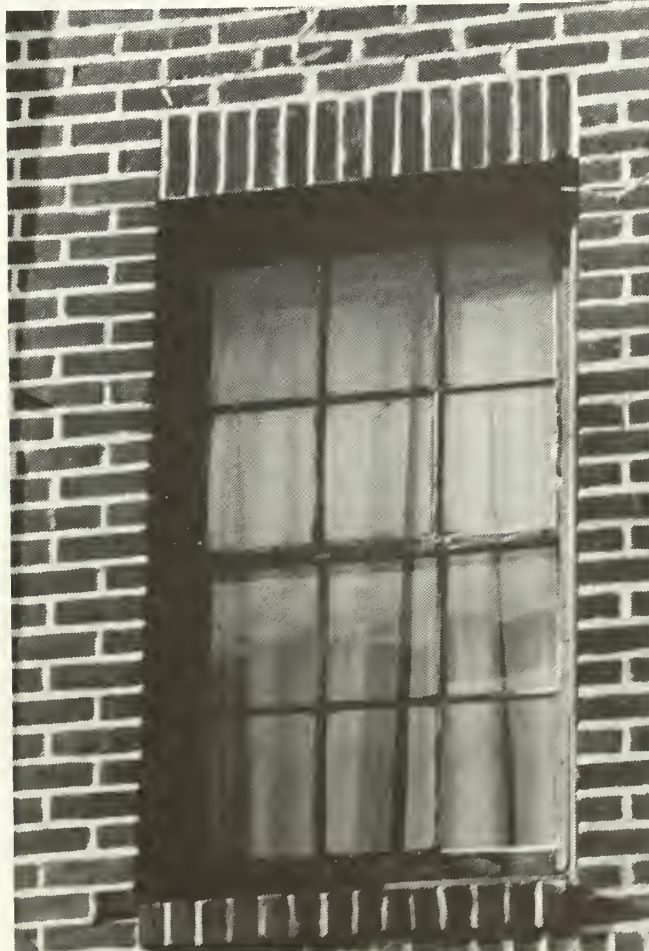
6. Proposed replacement window, exterior. Note rectangular panning, extensive subframe creating additional shadow lines. Compare the meeting rail and muntin dimensions with the historic sash in 4-5.

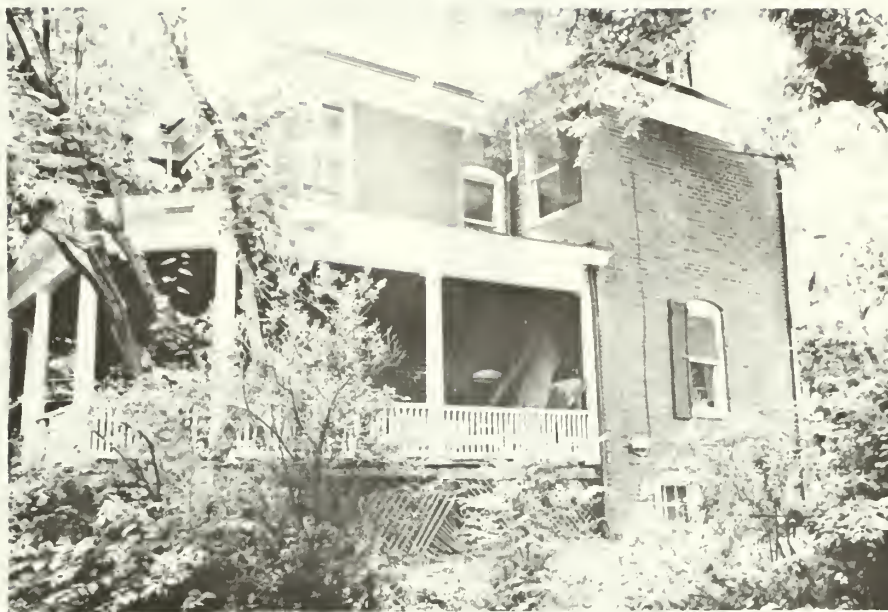
1. The c. 1915 freestanding residential structure is visible from all four sides; an unadorned brick side wall is a foil for the most distinguishing feature of the house--the wood wraparound porch.

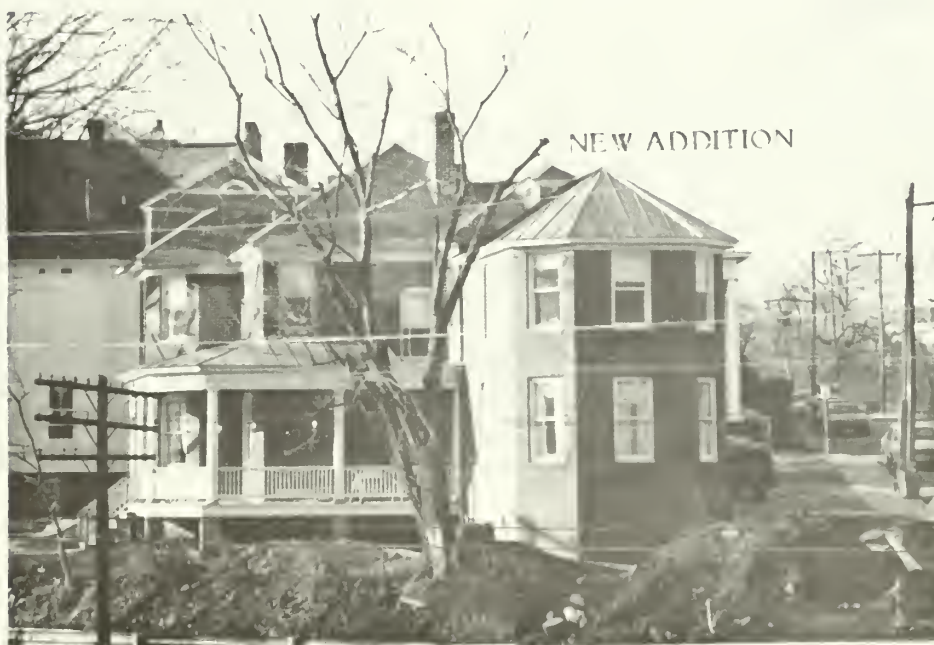
2. A new dormitory wing has been constructed on the side elevation shown in illustration 1. Because of its height, degree of projection, distinctive shape, and high visibility, the new addition has become the dominant feature of the house and has changed the historic character.

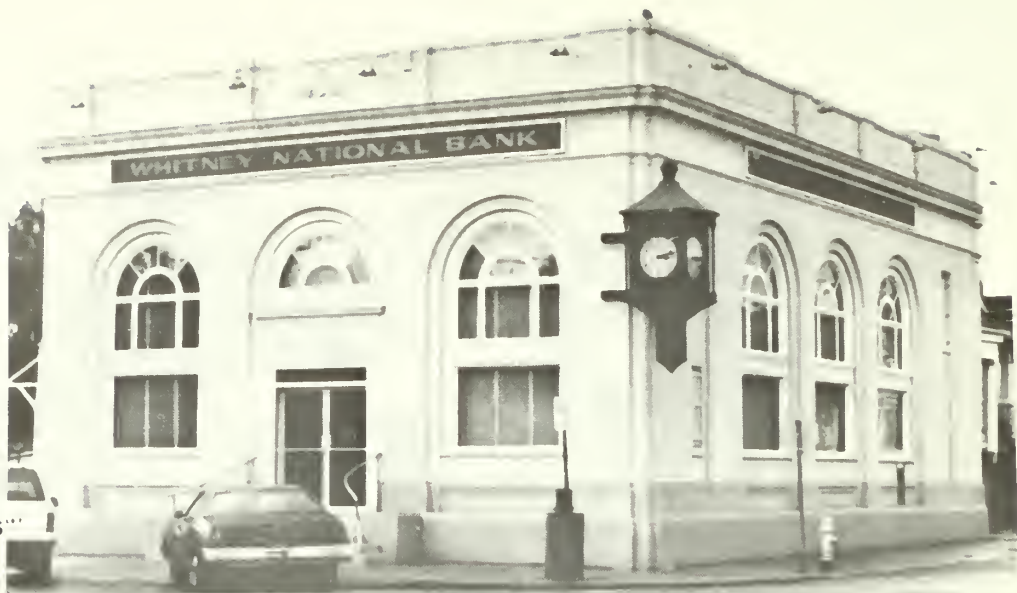
3. This freestanding bank structure, located at a major intersection in the district, was readily identifiable before rehabilitation by its simple rectangular form and its large, arched openings.

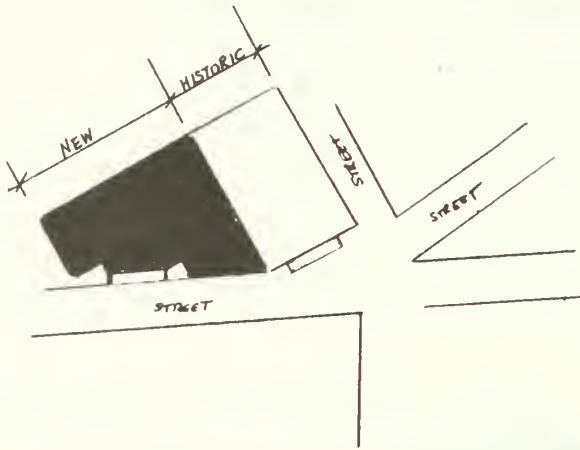
4. The historic bank and new bank addition are shown in relationship to the surrounding streets in the district. The previously rectangular form of the freestanding bank has been dramatically altered by both the size and shape of the addition.

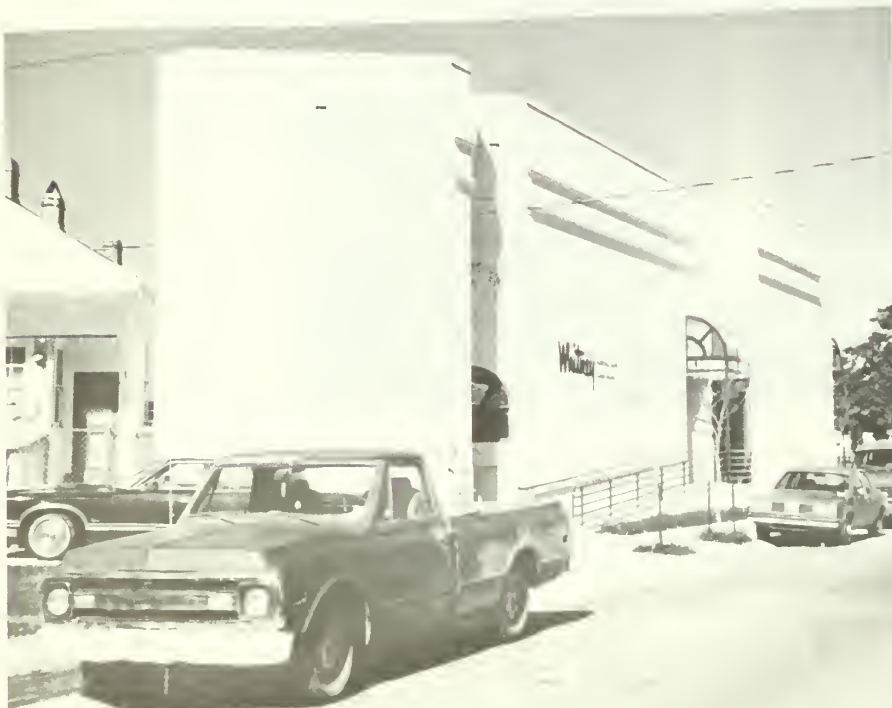
5. Even with a setback, appropriate height, compatible materials, and clear differentiation between new and old, the new work now dominates the resource and the setting. The historic bank can no longer be seen from a major side street.

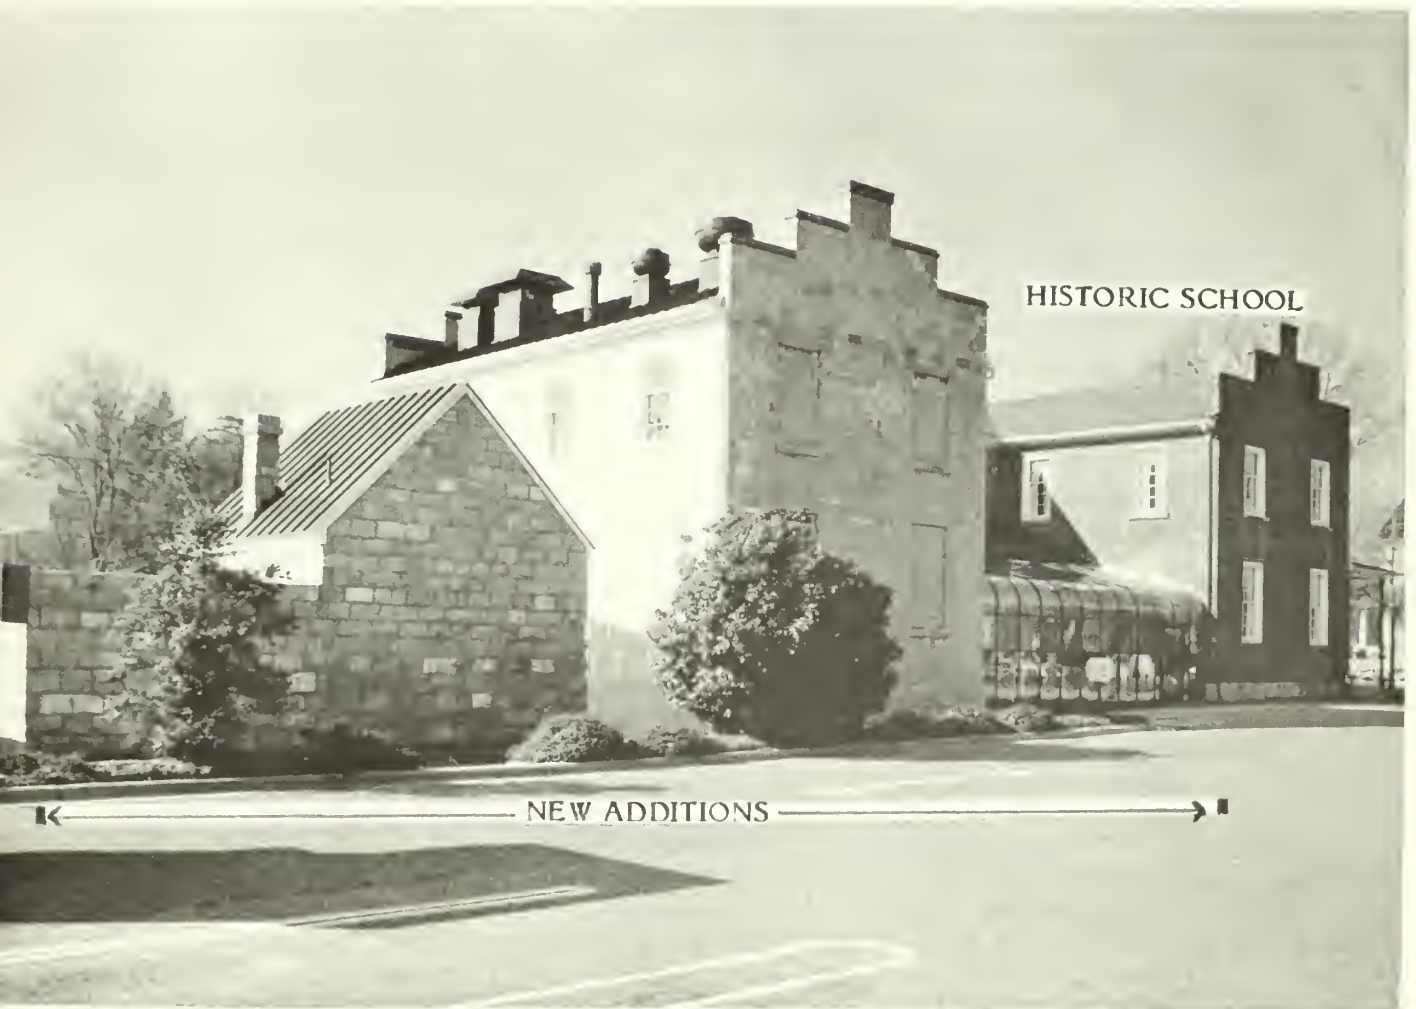
6. The side and rear elevation of the 1839 brick school building are shown here on the far right (the later ell is not visible) together with three new components added as part of the rehabilitation project--a greenhouse, a kitchen building with stepped gables matching the historic building, and a storage building. Because the new addition has changed the historic character to a dramatic degree, the project was denied tax incentives. A smaller kitchen wing--planned and sited differently--could have been in conformance with the Standards. The greenhouse itself was not an issue.

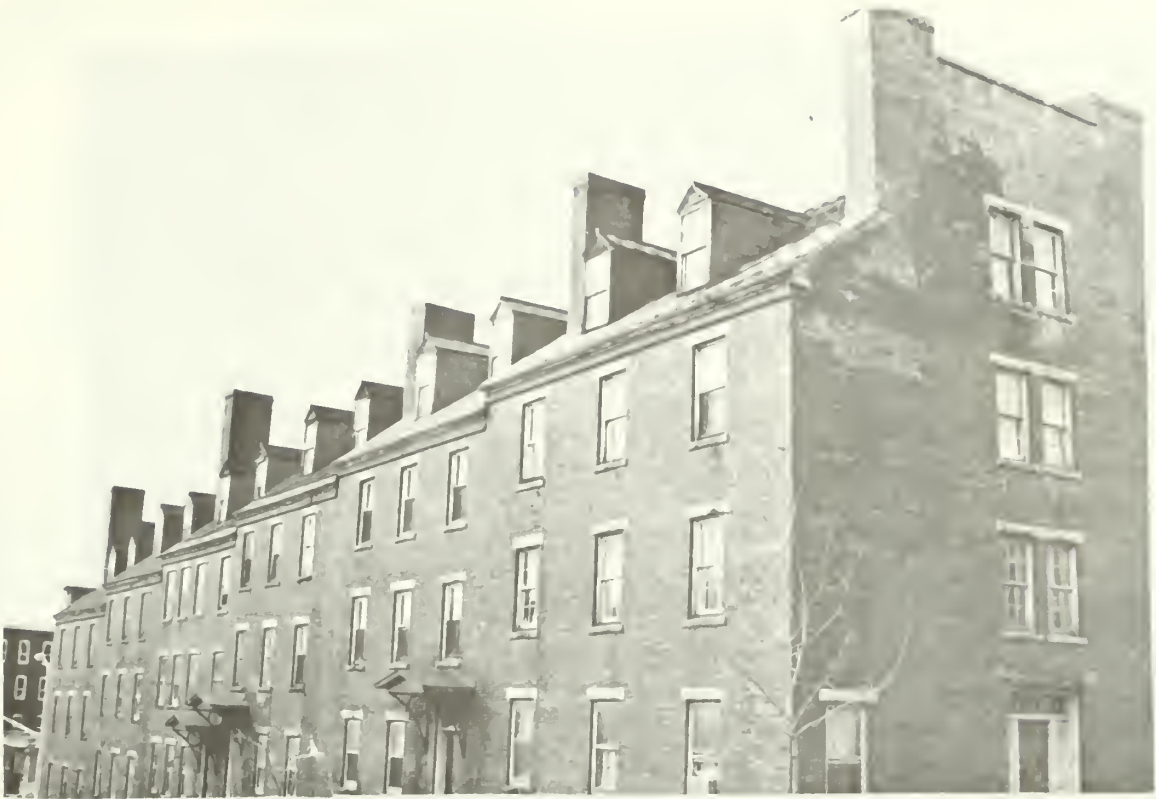
1. The historic character of the structures as mill workers' housing remained; that character, as NPS noted, was still forcefully conveyed by both the exterior and the interior.

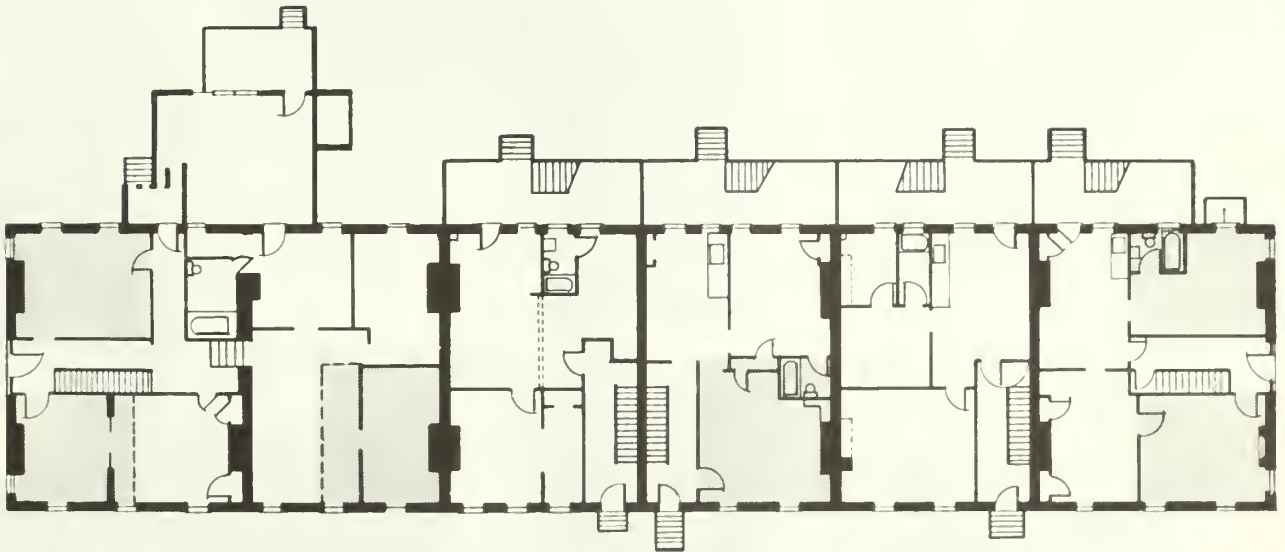
2. The plan shows room size and arrangement; units converted to two-story spaces by cutting through the first floor are denoted by shading.

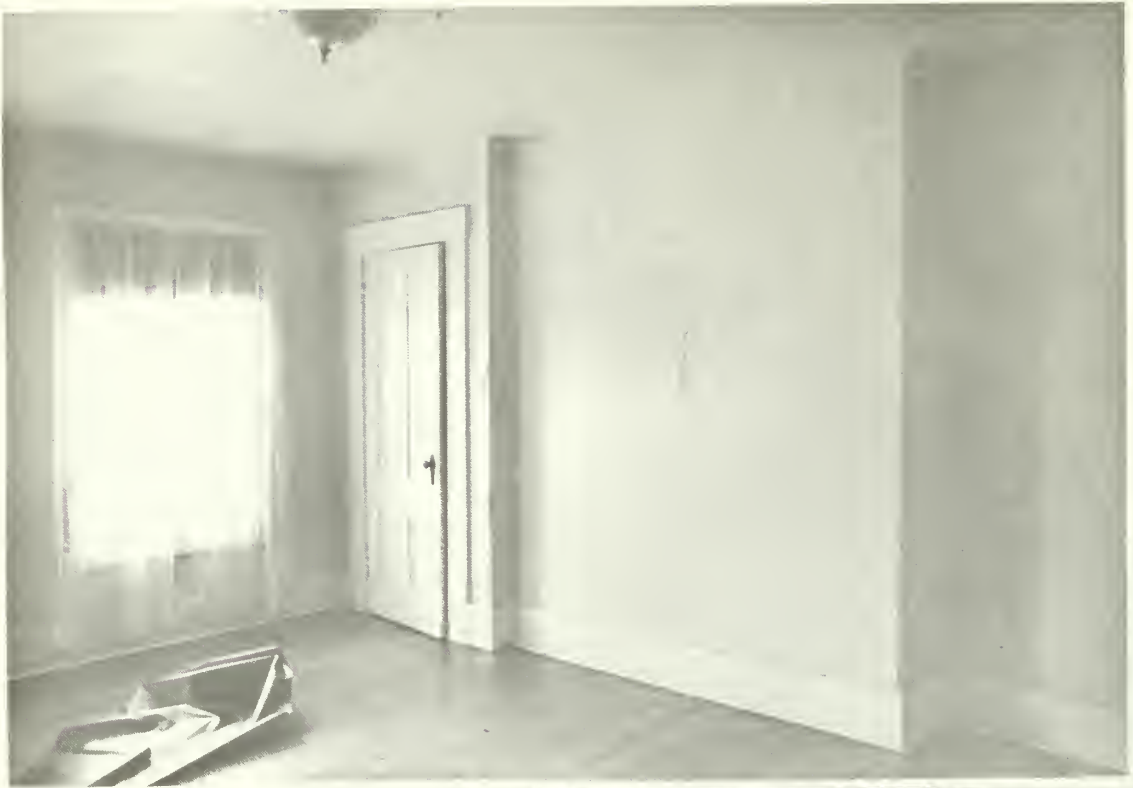
3. A typical room prior to rehabilitation, defined by ceiling, room space, and simplicity of detailing.

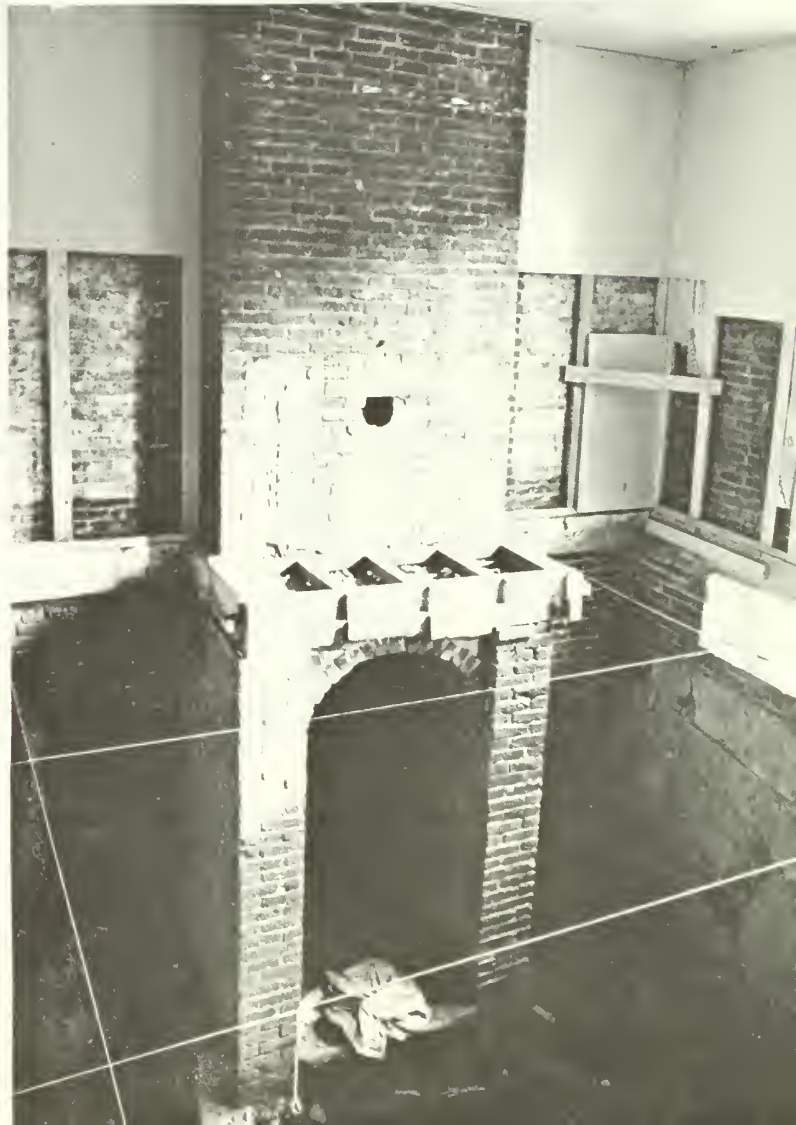
The character of the historic interior spaces appears to have been easily adaptable for modern residential use. Unfortunately, during the course of your rehabilitation work on these units, large portions of the first floors were removed in order to create two-story spaces. The creation of those two-story spaces required the destruction of both historic material and the distinguishing spatial concept of the most significant areas of each house, in violation of Standard 2. Furthermore, the design character of the new space is incompatible with the vernacular character of the building, thus violating Standard 9.

4. As part of the rehabilitation, the historic space was dramatically redefined by removing the first story floor, revealing the basement level. Two separate rectangular spaces were then made into one rehabilitated living unit. This inappropriate treatment violated both
